**URGENT - Field Safety Notice**

Philips EPIQ Ultrasound Systems  
Control Panel Arm Swivel Locking Failure

12-JUL-2021

**Reference:** Philips EPIQ Ultrasound Systems Control Panel Arm Swivel Locking Failure FCO79500549.

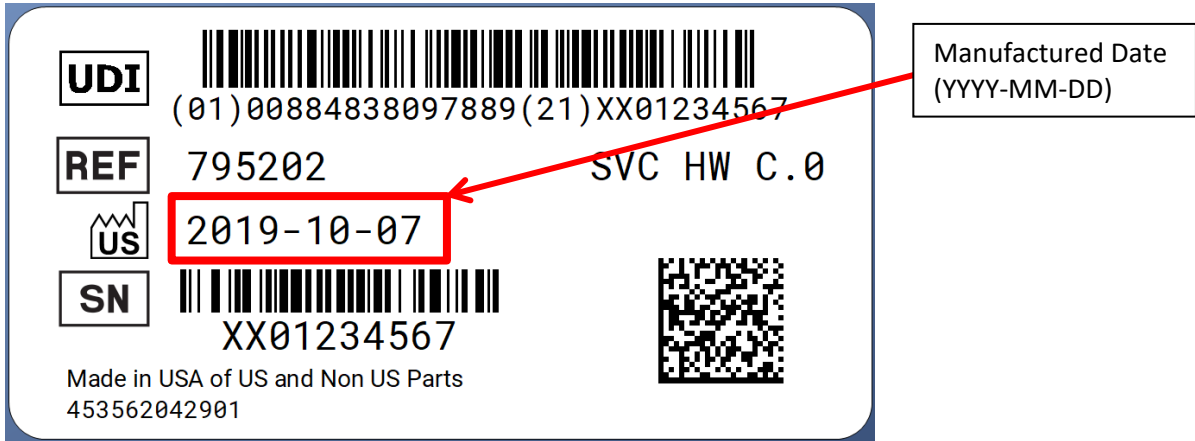
System	Model	Manufactured
EPIQ	EPIQ Elite EPIQ 5G EPIQ 5C EPIQ 5W EPIQ 7G EPIQ 7C EPIQ 7W EPIQ CVx EPIQ CVxi	Between 2020-02-27 to 2021-05-25 (Refer to the main system label shown below for the manufactured date)
