**URGENT Field Safety Notice**

Philips Intuis Systems  
Intermittent loss of X-ray

22-Sept-2021

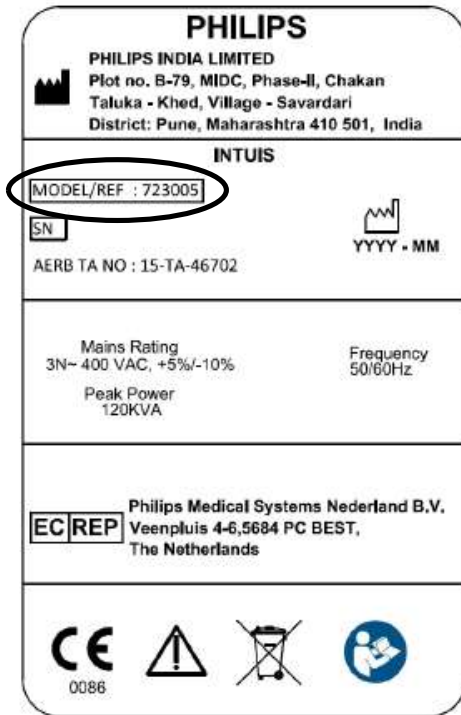
Affected systems can be identified through the model number on the System identification label placed on the C-arm stand cover.

Figure – 1: Philips Intuis label placed on the C-arm stand cover.
