**Update - Field Safety Notice  
Philips Respironics - Hospital Respiratory Care**

**Philips V680 Ventilator  
Software correction regarding error code 1008 - 2020-CC-HRC-004/ FCO86600058**

27-May-2022

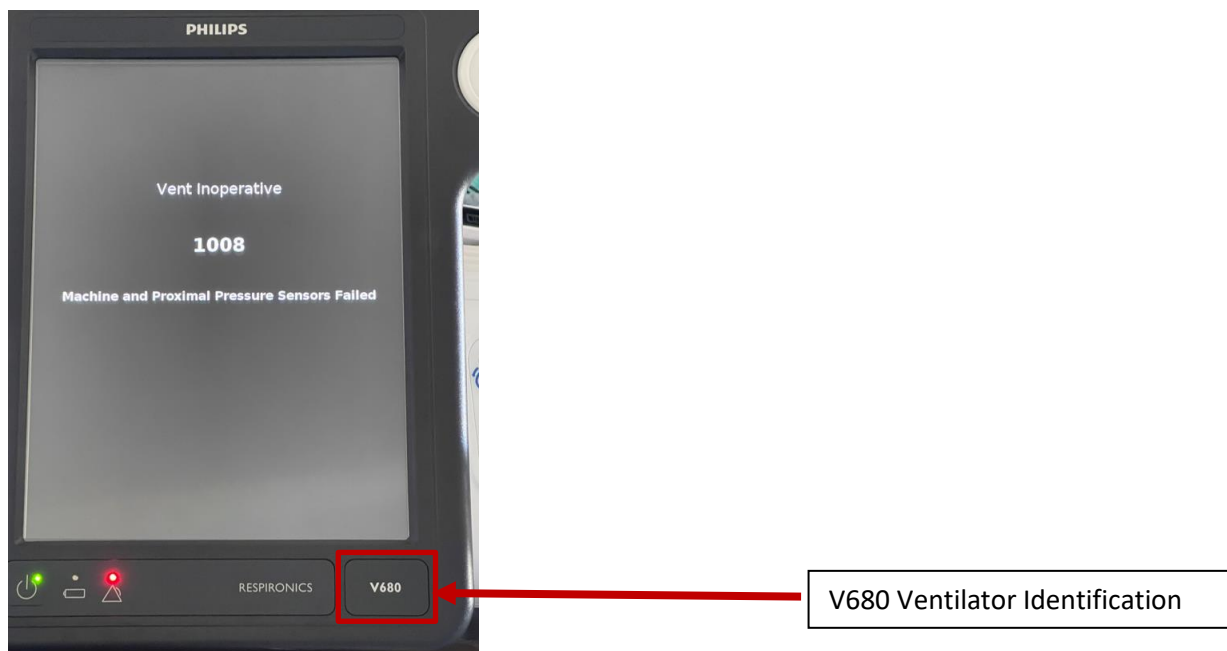
During dual-limb invasive ventilation, a patient cough of sufficient magnitude to drive circuit pressures above 95 cmH<sub>2</sub>O for longer than 150 milliseconds may cause a “Vent Inoperative 1008: Machine and Proximal Pressure Sensors Failed” alarm (image shown below), which will cause the V680 ventilator to cease therapy and the ventilator will not function, however, it will remain powered on.

Philips has received one (1) report of a death and three (3) reports of serious injuries associated with the 1008 Error Code on V680 devices.

As stated above, if there is a “Vent Inoperative 1008: Machine and Proximal Pressure Sensors Failed” alarm, this will cause the V680 ventilator to cease therapy. A cessation of ventilator therapy while in use on a patient could potentially lead to severe hypoxemia and hypercarbia.

As described above, Philips will be deploying Software Version 1.40 which includes a change to prevent the 1008 error code from occurring as a result of a patient cough.
