Product Notification

May, 2022

SP-50 Sensor short circuit

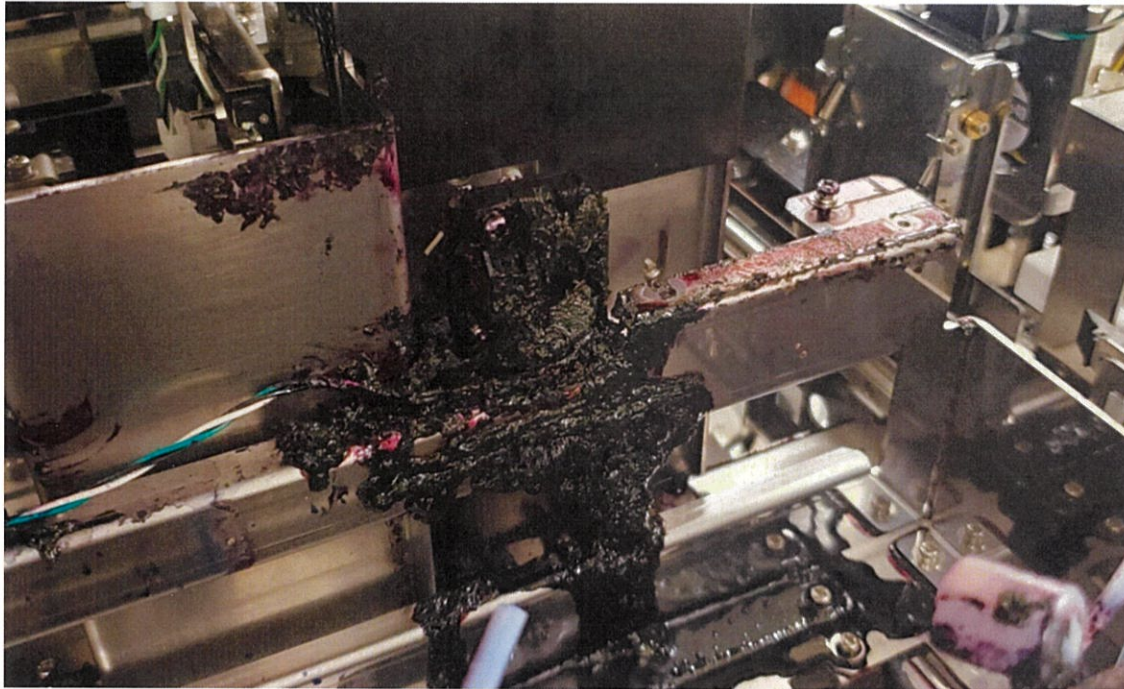
Pic.1

Customers noticed burning odor from SP-50 around stain pool area. After further investigation it turned out that stain buildup from stain pool was accumulated on the stain pool insert detect sensor, causing short circuit (Pic.1). 2 customers experienced this issue.

Waterproof covers will be installed to detection sensors.

Silicone rubber will be applied to the part caused short circuit.
