Urgent Medical Device Correction

Pump Weld Update for HeartWare™ Ventricular Assist Device (HVAD™)

27 July 2022

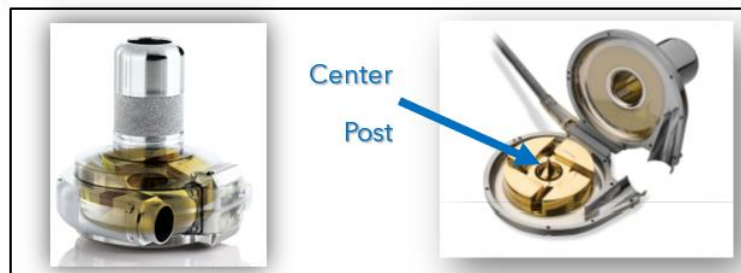
Figure 1: Pump Assembly

Medtronic is providing this letter as a follow-up to our 27 April 2022 communication titled "Urgent Medical Device Correction" (attached), which communicated a pump weld non-conformance with the HeartWare™ Ventricular Assist Device (HVAD™) System where (3) pumps were identified to have an impeller rotating non-concentrically and contacting the center post of the pump (see Figure 1: Pump Assembly). Medtronic's investigation was not able to conclusively isolate this issue to a specific subset of pumps. This communication provides updated information on the number of events, additional event details, and root cause.

The investigation has determined that the occurrence of a weld crack is the result of a combination of factors that may include the initial presence of contamination in the weld area from previously applied substances as part of the manufacturing process, the misalignment of the cap and housing prior to welding, or the depth/thickness of the weld. Medtronic’s investigation employed multiple methods to isolate the issue to a specific subset of pumps including quantifying weld thickness, alignment indicators, and visual indications of contamination using over 8000 digital photos. Medtronic has found that there is not enough data available to conclusively isolate this issue to a specific subset of pumps.

Consistent with the 27 April 2022 communication, routine prophylactic explant of the HVAD device is not recommended, as risks associated with explantation may outweigh the potential benefits. Physicians should make the decision regarding explant and exchange of the HVAD pump on a case-by-case basis
