URGENT: Medical Device Correction Update
Follow up to November 2021 Notification (Phase 2)
Synergy™ Cranial (9733763) and StealthStation™ Cranial (9735585)
Biopsy Depth Gauge Cycle View Inaccuracy

16 August 2022

URGENT: Medical Device Correction **Synergy™ Cranial (9733763) and StealthStation™ Cranial (9735585)** **Biopsy Depth Gauge Cycle View Inaccuracy**

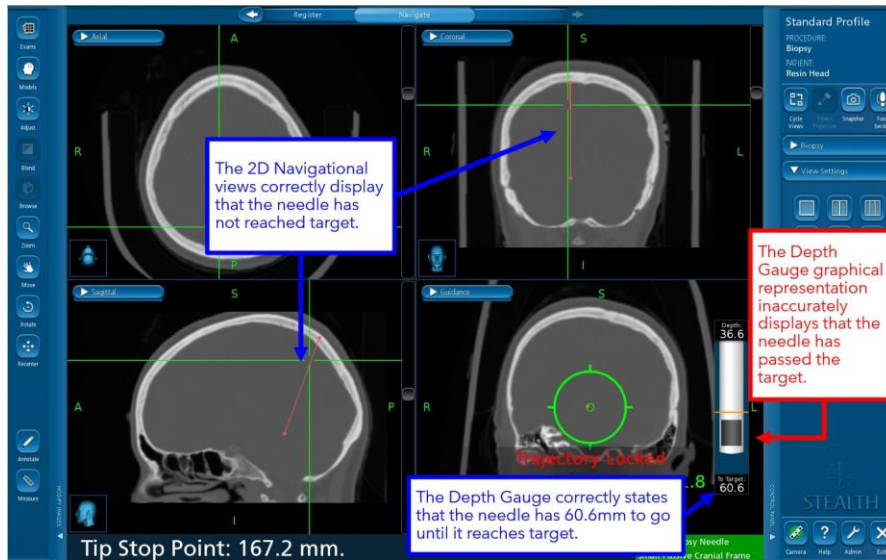
On June 9, 2021, a complaint was reported to Medtronic that during navigation in a Cranial Biopsy Procedure, the user may encounter an anomaly with the Biopsy Depth Gauge graphical display in the software. The software can enter a state where the Biopsy Depth Gauge is no longer synchronized with the rest of the navigational information on the screen and displays an inaccurate position of the biopsy needle.

Figure 1 Biopsy Depth Gauge Inaccuracy seen in Navigate Task

If performed, these actions may cause the Biopsy Depth Gauge graphical display to incorrectly depict the tip of the biopsy needle. The graphical depiction of the biopsy needle may appear in a position relative to the plan target that does not represent the actual physical position of the biopsy needle, which may result in potential biopsy of healthy tissue or damage to critical structures.

- Medtronic recommends **NOT** turning off **Guidance View** after locking the biopsy trajectory in the Cranial software.
- After locking trajectory for biopsy needle navigation, always ensure **Guidance View** remains an active view in at least one screen layout quadrant.

- **Step 1:** Obstruct the camera field of view of the biopsy needle or reference frame to **cause red status**.
- **Step 2: Return to green status** by no longer obstructing camera field of view of the biopsy needle and reference frame.
- **Step 3:** Use the **Cycle Views** icon to refresh guidance view and confirm that the biopsy depth gauge graphic matches the distance to target values and the position to target information provided by the 2D crosshairs.
- **Step 4: Visually confirm accuracy** before proceeding with navigation.
