FIELD SAFETY NOTICE – BDB-22-4547
BD Trucount™ Tubes and Kits
 Type of Action: Advisory Notice

31 October 2022

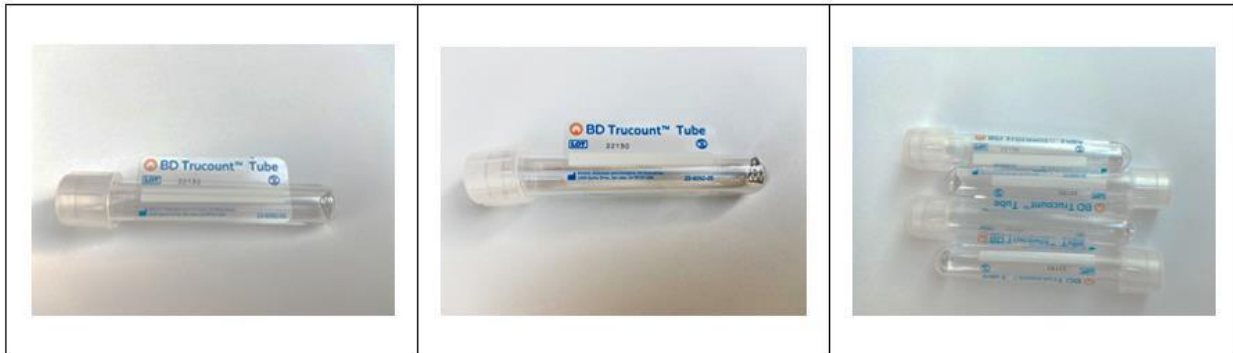
BD has confirmed through internal investigation that the labels applied to the BD Trucount™ tubes are becoming detached as shown in the pictures below:

Our investigation has identified an adhesive change made at a supplier resulting in the inadequate adhesion. BD is working closely with the supplier to resolve this situation expediently.

BD Trucount™ Tubes can cause automation errors when used with the automated loader for the FACSCalibur™, the FACSCanto™, and the FACS™ Lyse Wash Assistant. In these instruments, the loader moves the tube to the probe, the tube is lifted from its position in the loader for sampling, and then it is replaced into its position in the loader. If the label is partially detached, the tube cannot be fully replaced into its position in the loader.

1. Immediately review your inventory for the specific catalog and lot numbers listed above.
2. For any tube where label detachment is observed, BD recommends that the clinician remove the label from the tube and, using a permanent marker, record the tube lot number as well as any other relevant information directly on the tube as shown below:

1) Use one BD Trucount™ Tube lot at a time	2) Remove label from the tube	3) Write lot number and relevant information on the tube

Removal of the label prevents it from interfering with any auto-loading sample preparation and analysis systems, as well as from sticking to other tubes.
