URGENT MEDICAL DEVICE CORRECTION (NOTIFICATION)

Please be advised that Abiomed, Inc (“Abiomed”) has initiated a device correction (notification) to inform you of a potential issue with the Automated Impella Controller (AIC) not detecting an Impella pump when it is connected. Product is not being removed, and hospital inventory may continue to be used. As indicated in IFUs, Abiomed recommends having a back-up AIC available in the event of a device failure.

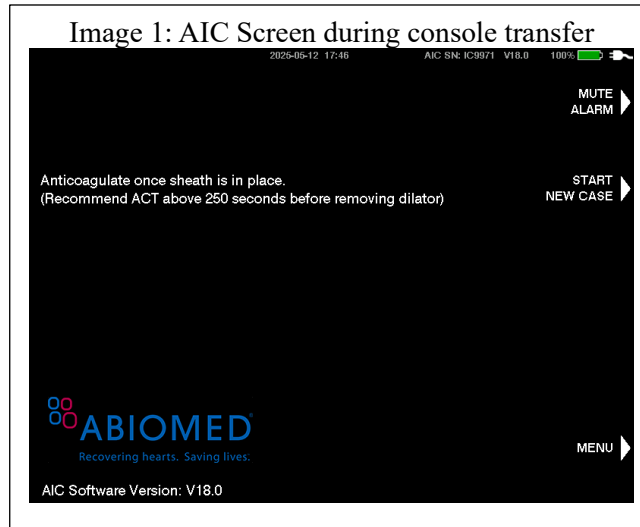
Abiomed has identified an AIC issue that may prevent the detection of an Impella pump when connected to an AIC. The pump detection issue may occur with any of the Abiomed Impella pumps and may occur during console-to-console transfer or at initiation of therapy at case start. There is no visual alarm

During console-to-console transfer, if the pump is not detected once connected to the AIC, the AIC screen in Image 1 remains and does not advance.

If the AIC screen in Image 1 remains for more than 20 seconds and does not advance after connecting the pump to the transferred console:

- Immediately switch the pump to the previous console to restore support to the patient.
- If the previous console displays an alarm message, switch to a different console if available.
- Restart the console that does not advance from Image 1 before attempting to re-connect a pump.

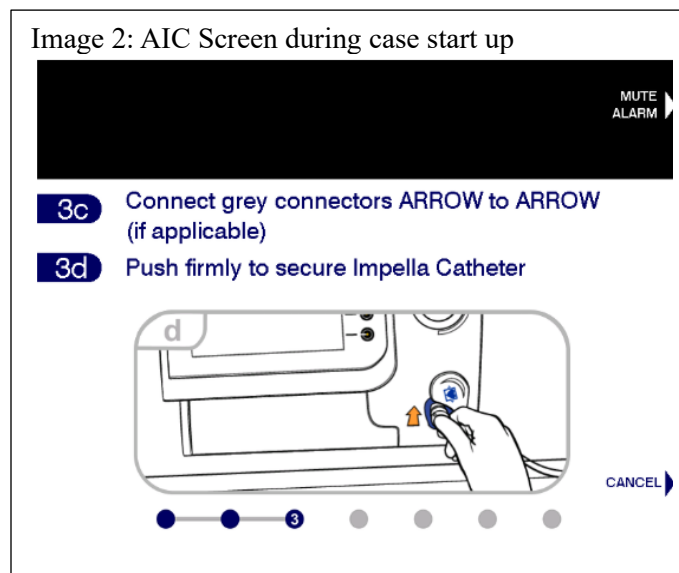
During case start, if the pump is not detected once connected to the AIC, the AIC screen in Image 2 remains and does not advance.

If the AIC screen in Image 2 remains for more than 20 seconds after connecting the pump and does not progress to indicate “Detecting Impella”, either re-start the case on the console or switch the pump to a different console.

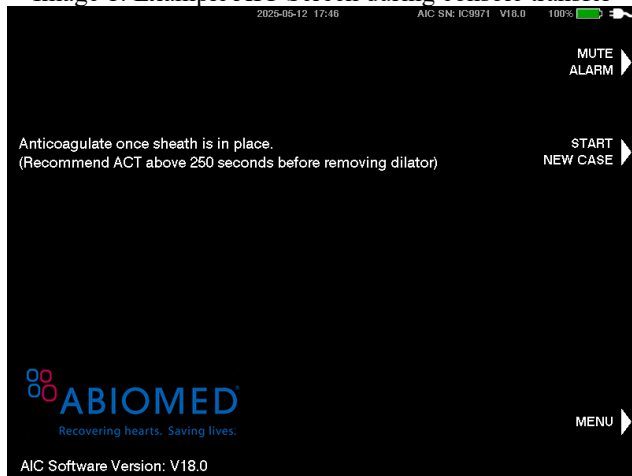
Image 1: Example AIC Screen during console transfer

During console-to-console transfer, if the AIC screen in Image 1 remains for more than 20 seconds and does not advance after connecting the pump to the transferred console:

- Immediately switch the pump to the previous console to restore support to the patient.
- If the previous console displays an alarm message, switch to a different console if available.
- Restart the console that does not advance from Image 1 before attempting to re-connect a pump.

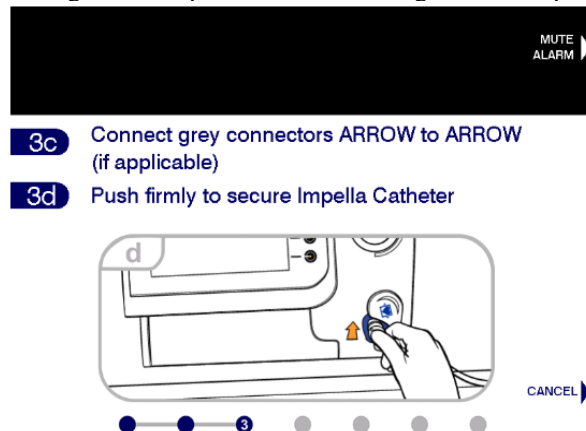
Image 2: Example AIC Screen during case start up

During case start, if the AIC screen in Image 2 remains for more than 20 seconds after connecting the pump and does not progress to indicate “Detecting Impella”, either re-start the case on the console or switch the pump to a different console
