URGENT MEDICAL DEVICE RECALL

BECKMAN COULTER DxC 700 AU
 BECKMAN COULTER CHEMISTRY ANALYZER AU5800

FA-001491

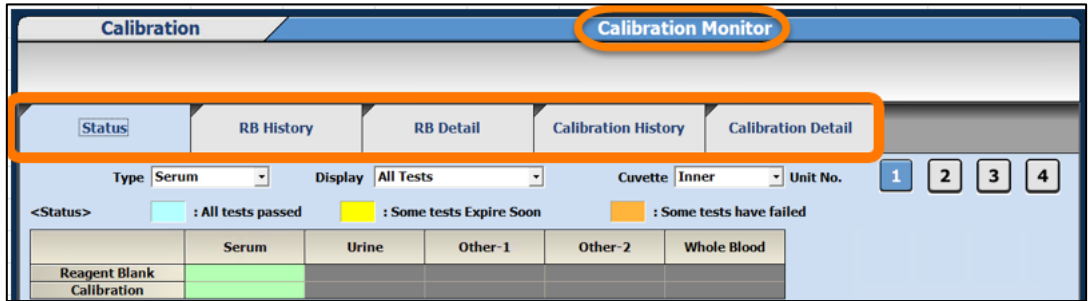
Picture2 for AU5800

ISSUE:	<p>Beckman Coulter has determined that the DxC 700 AU and AU5800 Clinical Chemistry Analyzers listed above may unexpectedly generate the errors described below when transitioning from Standby to Measure 1, or from Measure 2 to Measure 1, using PC pre-installed with Microsoft® SQL Server® 2022 Express, and analysis may not be started:</p> <ul style="list-style-type: none"> • 9000 PROGRAM ERROR (... CAL History DB Open Error.(SqlErr) ...) • 9000 PROGRAM ERROR (... RB History DB Open Error.(SqlErr) ...) <p>This error is caused by the inability to open the Regent Blank (RB) and Calibration databases. If this issue occurs, the system will stop analyzing, and Beckman Coulter Field Service Engineer (FSE) visit is required to restore the system.</p> <p>Our investigation has confirmed that this issue occurs when the Calibration Monitor remains open for more than 15 minutes. Refer to Picture1 and Picture 2.</p> <p>Picture1 for DxC 700 AU</p>

- Beckman Coulter has identified the root cause and will resolve the issue by applying a Software solution to the impacted systems. BEC service team will contact you to schedule the Software solution application, and a Field Service Engineer (FSE) will perform the on-site work.

- Until the Software solution is installed, please follow these precautions:
 - Do not leave the Calibration Monitor open for more than 15 minutes (including the five tabs under the Calibration tab: Status, RB History, RB Detail, Calibration History, Calibration Detail) even in modes other than Measure mode, such as Stand-by mode. Refer to **Picture3** (same as Picture1) for DxC 700 AU and **Picture4** (same as Picture2) for AU5800.

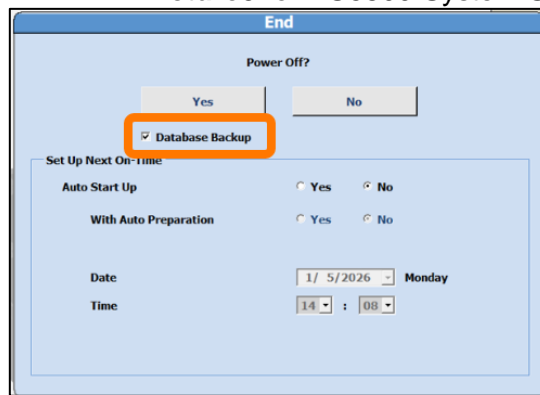
Picture5 for AU5800 System Shutdown (END Process)

- Perform System Shutdown (END Process) daily. (This backs up the RB and Calibration databases.) For AU5800, ensure the backup checkbox is selected during System Shutdown. DxC 700 AU does not have a checkbox as backup is done automatically when System Shutdown process. Refer to **Picture5** for AU5800 System Shutdown.
