URGENT MEDICAL DEVICE CORRECTION

GE HealthCare Ref. # 79072

RE: **Double image artifact with IC9-RS intracavitary probes**

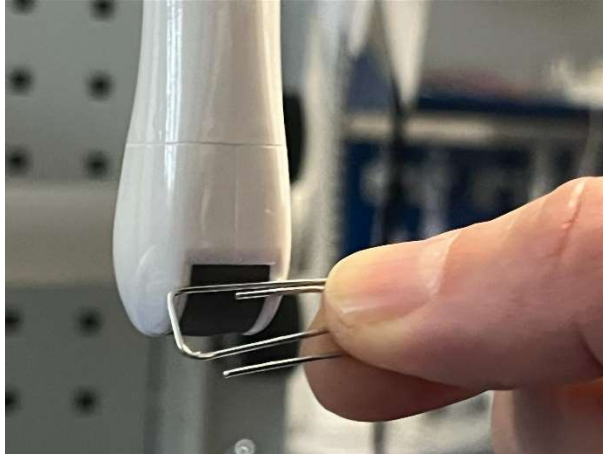
1. Run the edge of a smooth, metal reflector (paperclip, metal pen, flat side of tweezers or similar) along the probe lens starting at the edge of the field of view and running it along the full curvature of the probe (Figure 1).
2. The metal reflector will produce strong echoes localized at the point of contact.
3. To enhance the echoes, apply a smear of water on the metal reflector only.

Figure 1: Double image test procedure. Place metal reflector (paperclip shown) at the edge of the field of view. Run reflector along the full curvature of the transducer.

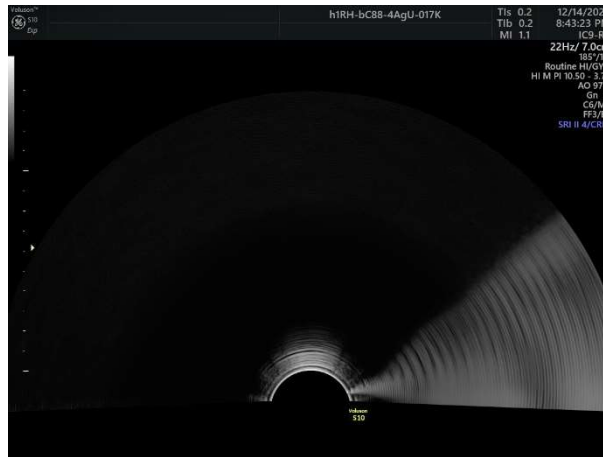
Figure 2. Test image from a normal IC9-RS probe. No artifact visible.

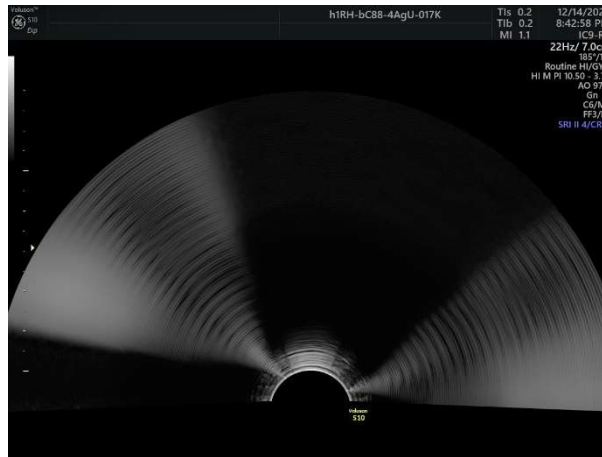
GE HealthCare has become aware of an issue with certain IC9-RS ultrasound probes (see Affected Products List) that can result in a double image artifact creating a ghost image with realistic features. An unrecognized artifact may lead to misdiagnosis.

If an additional echo is seen in the sector opposite of the point of contact, the probe is producing a double image artifact. Double image artifacts are only visible towards the edges of the field of view. See test images below from a normal IC9-RS probe (Figure 2) and a malfunctioning IC9-RS probe producing double image artifact (Figure 3).

Figure 3. Test image from a malfunctioning IC9-RS probe showing double image artifact in the opposite sector.

GE HealthCare will correct all affected products at no cost to you. A GE HealthCare representative will contact you about the correction method and schedule.

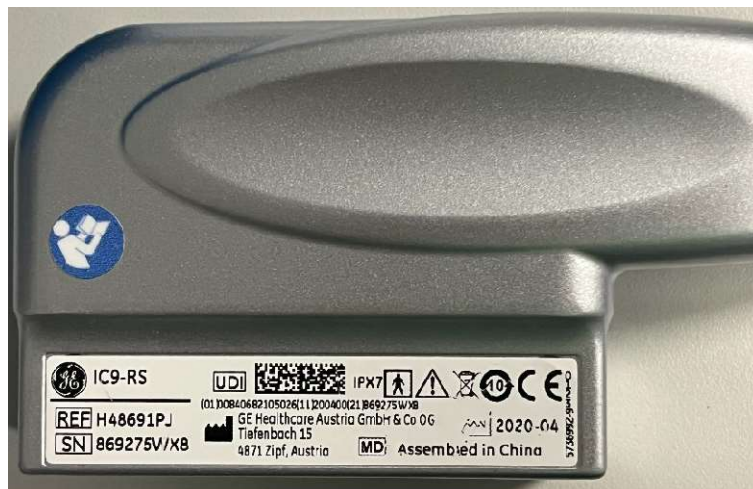
IC9-RS probes with a serial number included in Appendix A are affected by this issue. The serial number (SN) can be found on the rating plate as shown in Figure 4

Figure 4. Rating plate example – displaying probe type (IC9-RS) and serial number (SN).
