URGENT Field Safety Notice

Philips Azurion Systems R1.x and R2.x

Software issue potentially resulting in loss of imaging (X-ray) functionality

28-MAY-2025

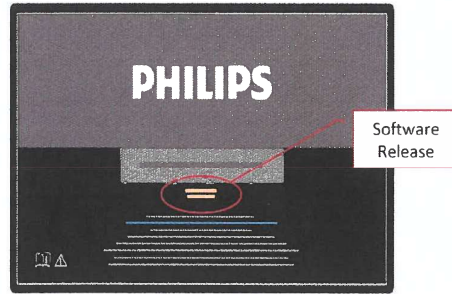
Figure 1- System Identification Label

The System Product Name and Model Number can be found on the System Identification Label located on the System stand (Figure 1). The software version of the Philips Azurion systems can be identified during start-up (Figure 2).
