Date: July 20, 2025

## **Field Safety Notice**

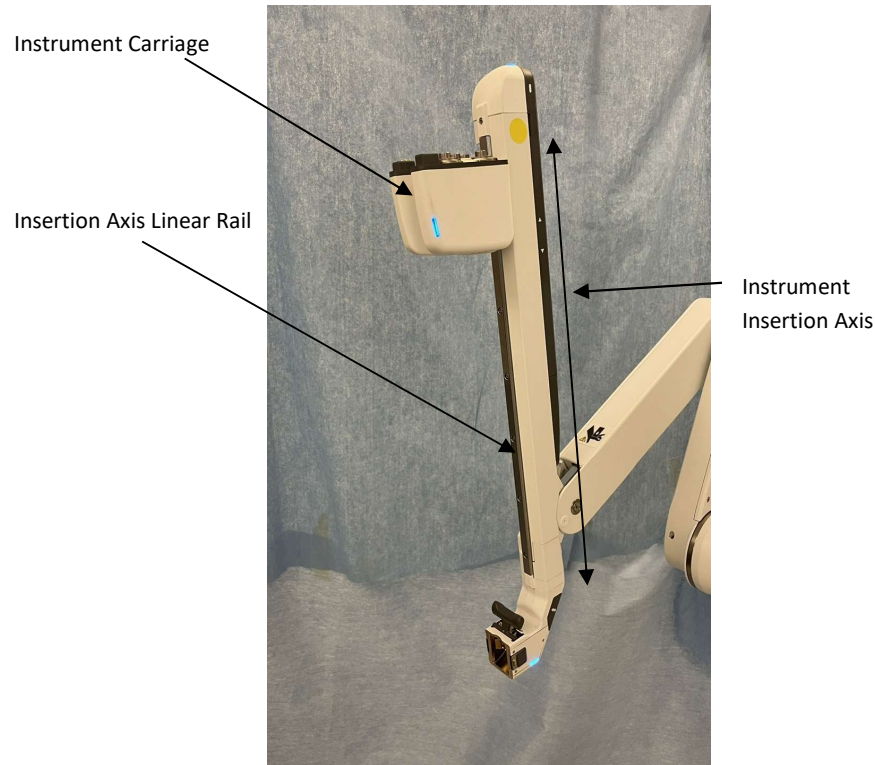
Figure 1: Instrument Carriage and Insertion Axis Rail on Instrument Arm

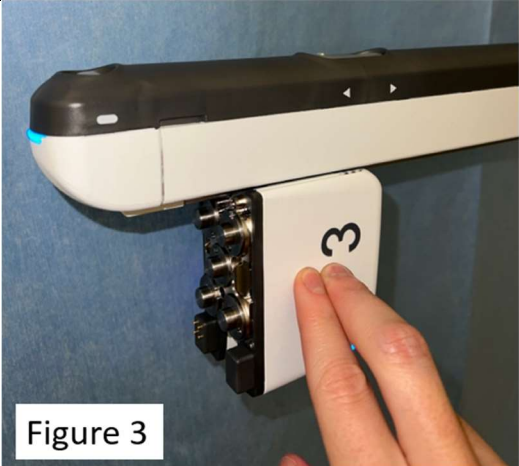
<p>Figure 3</p>
<p>Closely inspect from all angles the interface between the Instrument Carriage and arm (inspection area in red box, Figure 4) and evaluate the interface using the below Pass/Fail criteria. <b>This must be done on the right-hand side of the Instrument Carriage, as defined in Figure 1.</b> Repeat all steps for all remaining arms.</p>

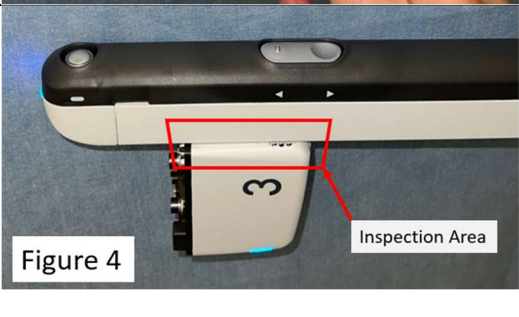
<p>Figure 4</p> <p>Inspection Area</p>
<p><u>PASS:</u> Unable to see serial number <u>and</u> barcode (Figure 5).</p> <p>Acceptable to use system.</p>
