Reference: 2026-003M

URGENT - FIELD SAFETY NOTICE

To all users of **Olympus HF Cable, Bipolar**

Re: Olympus to Remind Customers of HF Cable IFU Information.

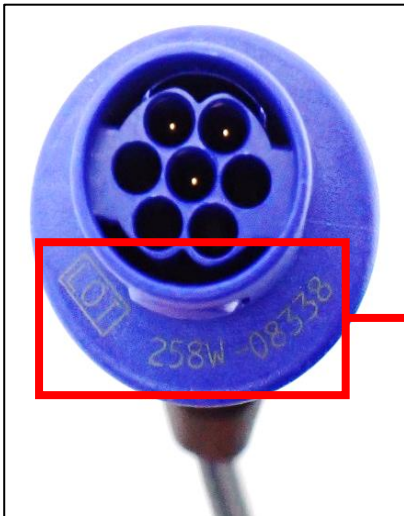
Figure 1: Generator plug housing

To follow the IFU, determine the service life of the device. To assist in determining the device's service life, the manufacturing month and year can be obtained from the lot number shown on the front face of the generator plug housing, as illustrated below.

Lot number format: **YYMW-00000***

- **YY** = year manufactured (e.g. 2025 = “25”)
- **M** = month manufactured (Jan to Sep = “1” to “9”, respectively. Oct, Nov, Dec = “X”, “Y”, “Z”, respectively)
