URGENT Field Safety Notice

BiPAP A30, BiPAP A40 and OmniLab Advanced+
Motor Stator Material Non-Conformance

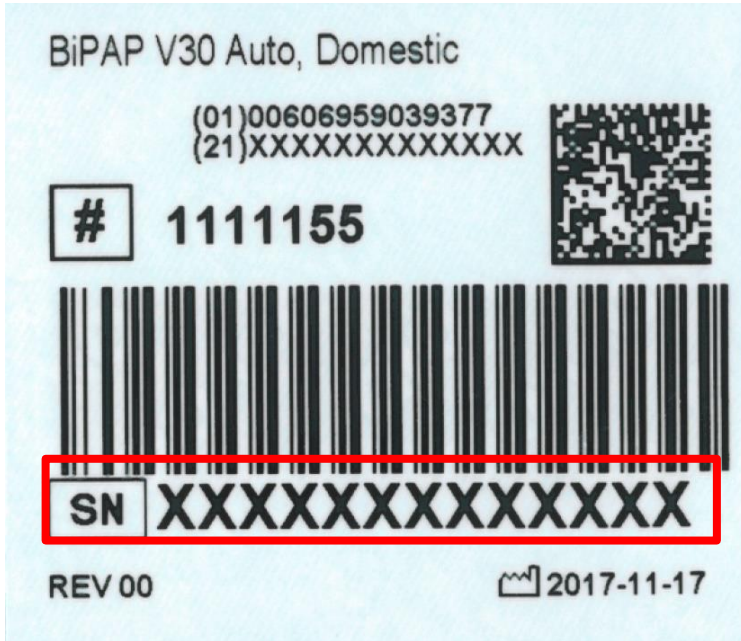
Your device is part of the impacted population if the device serial number matches any of the serial number listed on the attached. The device serial number is located on the bottom of the device on the product label or on the device packaging label as shown below.
