UPDATED: URGENT Field Safety Notice

Trilogy Evo, Trilogy Evo O2, Trilogy EV300
Non-pneumatic Nebulizer Use, Flow Sensor Nebulized Aerosol Deposition, and Obstruction Alarm

19 Feb 2026

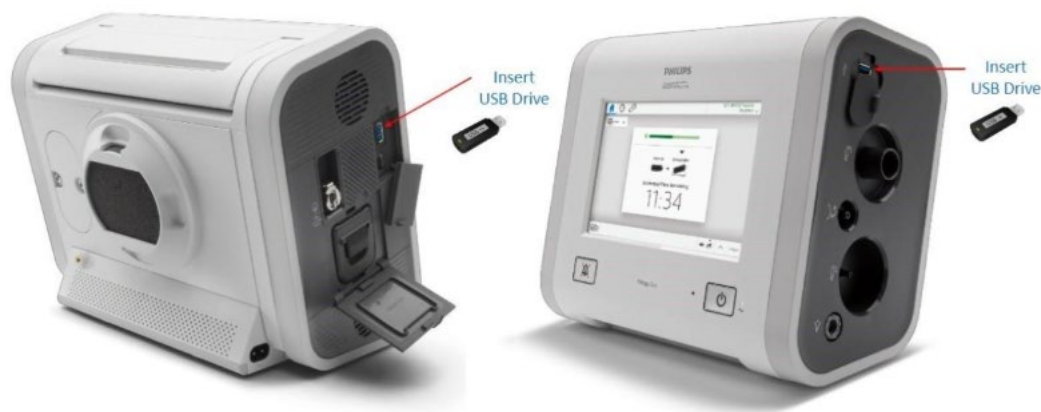
1. Connect device to AC power. Press On/Off (Standby) button.
2. Insert the USB-drive in either of the two USB ports of your device.

3. Go to the OPTIONS window (wrench icon) > Data Transfer
4. The device will recognize the USB drive and will show the Software version on the “Install Software Update” box. Click on that box.
5. Confirm that you are upgrading the device to the latest version and click YES
6. Trilogy Evo is now installing the new software. Please wait.
7. A confirmation of Software installation complete will be shown. Press OK and turn the ventilator ON.

To confirm that the software has successfully downloaded, go to the OPTIONS window (wrench icon) and select INFORMATION. Locate the Software Version Number on the screen and confirm that the version is 1.06.15.00.
