URGENT Field Safety Notice

M5071A (adult) and M5072A (infant/child) pads for use with HS1/OnSite/Home AEDs may experience gel separation and reduction of gel surface area

21-FEB-2022

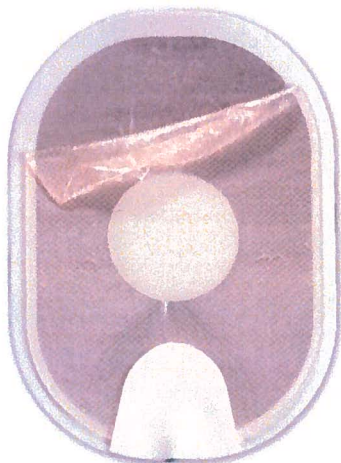
When a pad with separated, folded gel is placed on the patient's bare skin, the HS1/OnSite/Home AED could deliver less effective or ineffective therapy to the patient due to the reduced surface contact area with the skin. See example picture in **Figure 1**.

Figure 1: Separated gel that has folded onto itself when peeled.

Action:
Apply pads to the patient.
Do not hesitate.

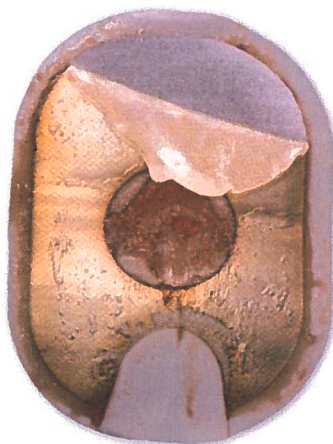
Separated, folded gel may also have a discolored and/or melted appearance. While the gel may also have a discolored and/or melted appearance, the appearance does not have any impact on the delivery of therapy; however, there may be a delay in therapy if the user hesitates to apply the pad due to its appearance, and the AED may deliver less effective or ineffective therapy to the patient due to the reduced contact area with the skin. See example picture in **Figure 2**.

Figure 2: Separated, folded gel may also have a discolored and/or melted appearance.

Action:
Apply pads to the patient.
Do not hesitate.

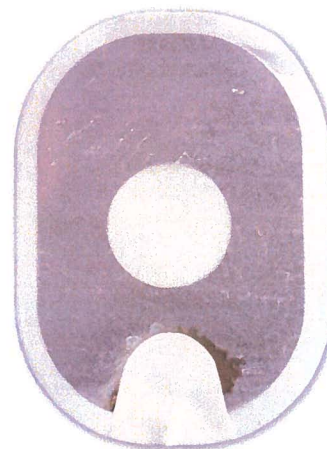
It is also possible that the gel could separate almost completely from the foam/tin backing when peeled, (see **Figure 3**.) Due to a small amount of gel surface contact area with the skin, electrical arcing could occur when a shock is delivered leading to burns to the patient's skin, or the AED could be unable to deliver any shock through the pads. A delay in therapy will result while the user installs a replacement pads cartridge (if available) or performs CPR while waiting for Emergency Medical Services Personnel to arrive. For comparison, **Figure 4** shows a normal pad. No matter the state of the pad, follow the voice prompts because the AED will step you through the necessary actions.

Figure 3: Gel almost completely separated from backing.

Action:
Replace pads cartridge if a spare is available. If no spare is available, perform CPR until help arrives.

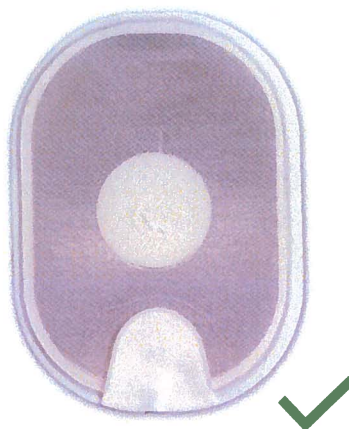
Figure 4: Normal pad.

Action:

Apply pads to the patient according to the Instructions for Use/Owner’s Manual.
