URGENT - FIELD SAFETY NOTICE

To all users of **Single Use Biopsy Valve**

Product Name	Model/Catalog Number	Serial/Lot Number(s)
Single Use Biopsy Valve (Sterile)	MAJ-210	All unused/unexpired

Re: Olympus Emphasis on Strict Adherence to Instructions for Use (IFU)

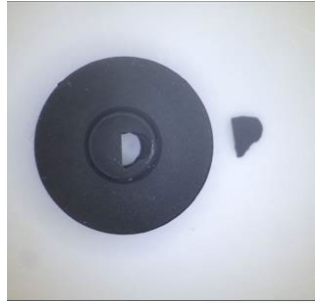
Figure 1: MAJ-210 slit fragment detachment.

Olympus is currently investigating an increase in complaints associated with rubber fragment detachment in the slit of MAJ-210 and *MAJ-1218 Single use Biopsy Valves as shown below in Figure 1. While the investigation regarding the cause of the issue is ongoing, Olympus is highlighting the importance of strictly adhering to the 'Inspection of the Biopsy Valve' and 'Inserting and Withdrawing the Endo-therapy accessories' sections in the IFU related to the detachment of fragment from the slit part of rubber, as shown below in Figure 2 and Figure 3 below.

- Inspect the valves for damage or cracks
- Insert endo-therapy accessories as straight as possible
- Angled Insertion and withdrawal of endo-therapy accessories can cause resistance and could cause damage to the valve.
