URGENT MEDICAL DEVICE CORRECTION

GEHC Ref# 32081

RE: **Mounting issue for Lullaby™ Resus Plus/Prime dovetail mounts onto Lullaby™ Warmer side rails**

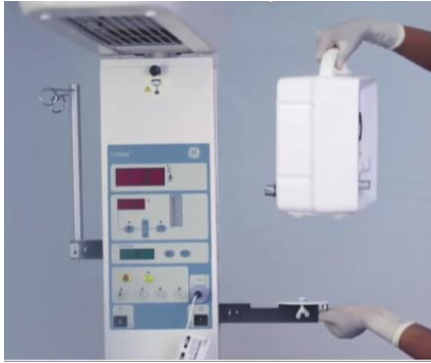
1. Lock wheels of the Lullaby™ Warmer.
2. Disconnect Air/Oxygen hoses of the Lullaby™ Resus Plus/Prime device (If they are connected).
3. Disconnect the Lullaby™ Resus Plus/Prime from the dovetail mount accessory. See Fig 2 for details.

Fig 2. Disconnect and remove Lullaby™ Resus Plus/Prime from the dovetail mount

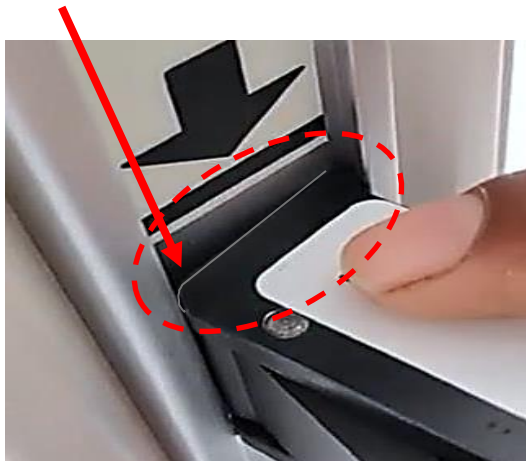
Gap between the dovetail mount and the rail

Fig 3 Incorrect installation due to defective dovetail mount accessory (gap or opening presence)

5. If you find the incorrect installation as shown in the Fig 3, disconnect the dovetail mount, remove the mount from use, and destroy it.
6. If the Fig 4 conditions are observed, ensure that dovetail mount is firmly fixed by tightening the mounting screws. In the event the dovetail mount needs to be installed on a different Lullaby™ Warmer device, ensure to recheck for proper installation of the dovetail mount.

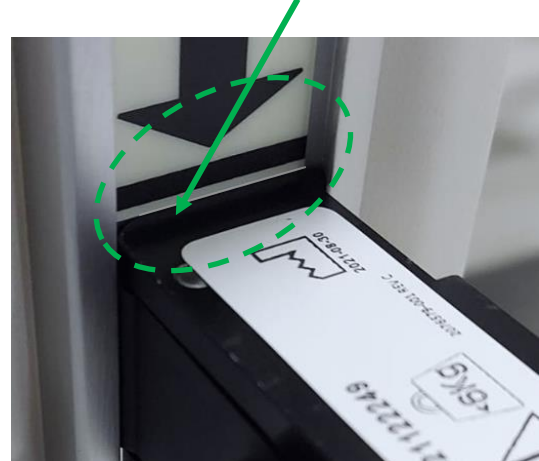
No Gap between the dovetail mount and the rail

4. Check for the proper installation of the dovetail mount with the dovetail rail. See Fig 4 for the correct installation condition.

Fig 4 Correct installation (full contact with no gap) of the dovetail mount with the dovetail rail
